APPLICATION STORY

MOBILE THERMOGRAPHIC MONITORING OF BELT CONVEYORS HELPS AVOID FIRES

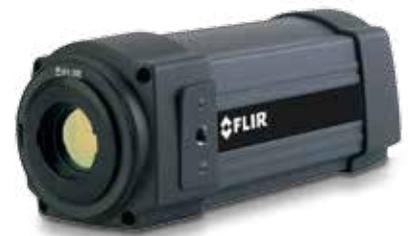
The FLIR A310 thermal imaging camera

(www.inau.de). He suggested trying a permanently installed thermal imaging camera from the FLIR A series. The FLIR A310 was mounted on the bed of an SUV and pointed in about a 45-degree angle to the direction of travel. Among other things, a special housing unit was required to securely mount the FLIR A310. The thermographic camera system can operate without any cable connection, because it includes a battery power supply and a wireless communication unit.

Klaus Flocke recommended a wide-angle lens to cover as much of the conveyor belts as possible while passing by. The A310 transmits the camera image via Wi-Fi to a tablet PC installed in the driver's cab. If a preset alarm temperature is detected, this tablet PC emits an acoustic warning signal. Only then the driver (who otherwise focusses entirely on driving about 20 km/h at a distance of 2-15 meters away from the conveyor belts) checks the image on the monitor and locates the overheated section of rollers on the conveyor belts.

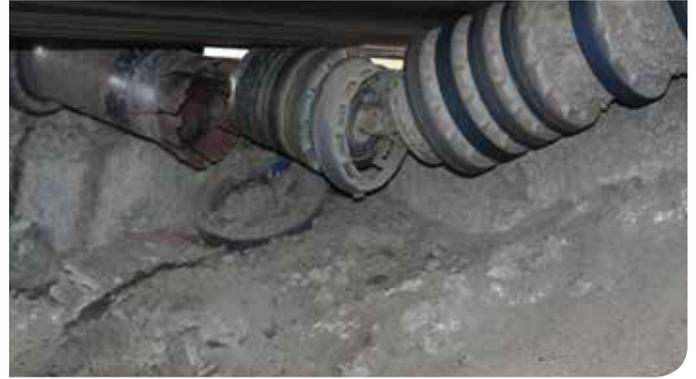
Defective lower support roller of a belt conveyor

At its strip mines, MIBRAG operates approximately 70 km of belt conveyors, which include steel rollers and idlers with rubber or polyurethane support rings. Wear on the bearings can cause overheating, which can ignite the lubricants and support rings of the lower rollers. Even the upper steel rollers can heat up to the point that the steel starts to glow. Especially when a belt conveyor is at a standstill, a large fire hazard can arise after just 10 to 15 minutes.

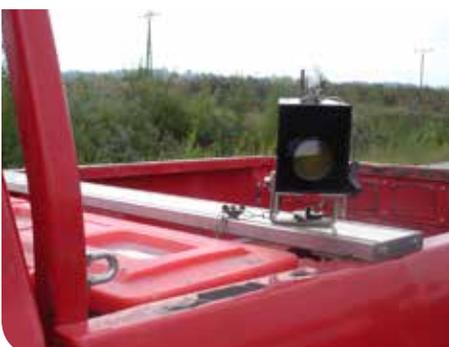
The FLIR A310 was mounted on the pick-up in a special protective housing
