Automatic quality controls with FLIR A320 ensure that the cars produced at Ford Genk work perfectly

FLIR A-Series thermal imaging cameras: accurate, reliable and maintenance free

APPLICATION STORY

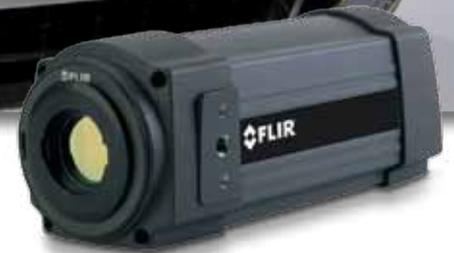
The FLIR A320 is an affordable and accurate non-contact temperature imaging and measurement tool.

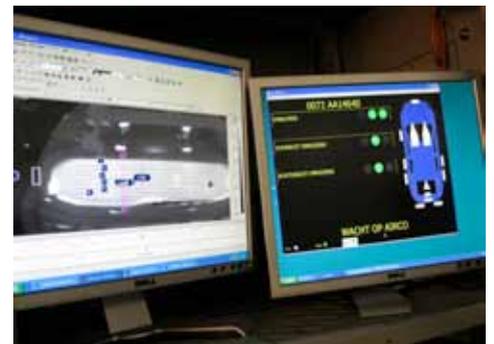
The programmable logic controller (PLC) compares the measurement data from the thermal imaging cameras with previously defined parameters.

The measurement data collected by the thermal imaging cameras are sent to the programmable logic controller (PLC), which compares the measured temperatures to previously determined parameters. If the recorded data is within those parameters then the car gets the green light to proceed. A screen next to the test site will display either a red or a green sign. If a red sign is shown the car must go to the repair department. If it is green the car can proceed to the next step in the testing range.

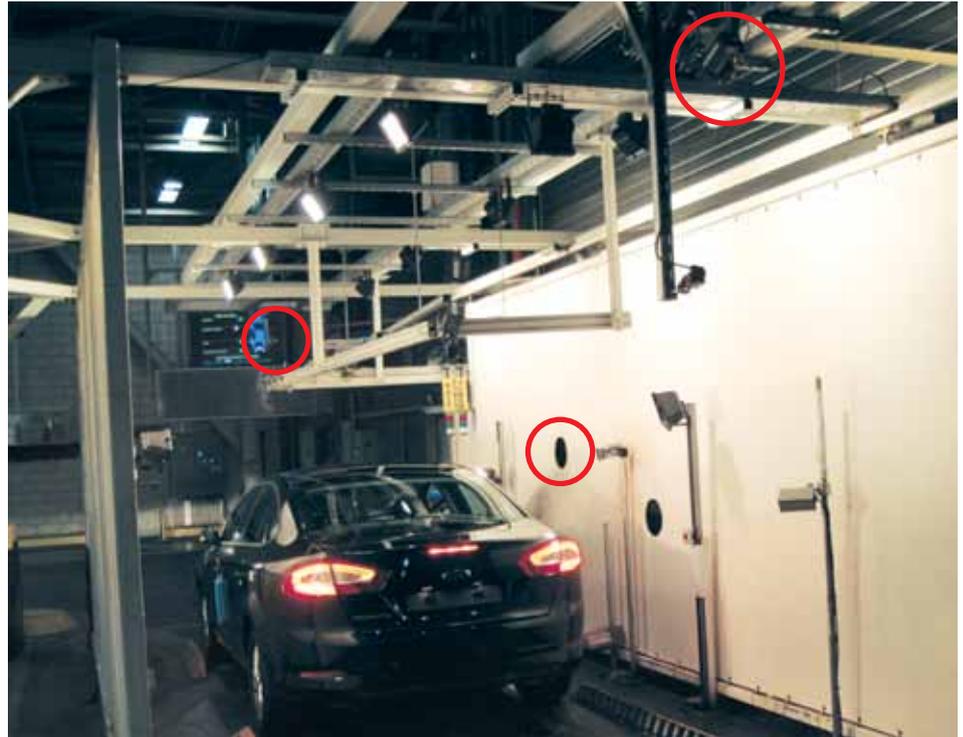
Ford Genk has three FLIR A320 thermal imaging cameras for testing the front window heating system, the rear window heating system and the air conditioning system. The locations of the thermal imaging cameras are marked in red.

temperatures of front window heating elements, rear window heating elements and the air conditioning vent outlet”, explains Knuyesen. “There’s one mounted in the front of the car, pointed at the front window, another mounted behind the car to monitor the rear view window and the third is pointed at the window of the car door at the right hand side, to measure the temperature of the air conditioning vent output.”

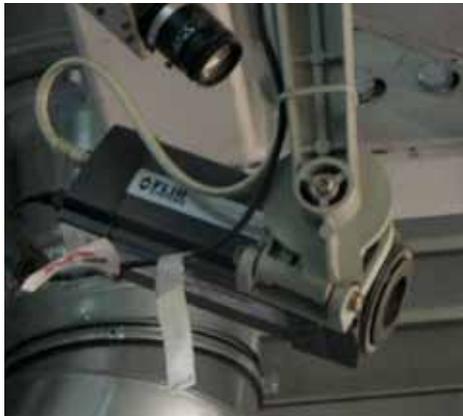
This FLIR A320 thermal imaging camera is used to check the front window heating system for defective heating elements.

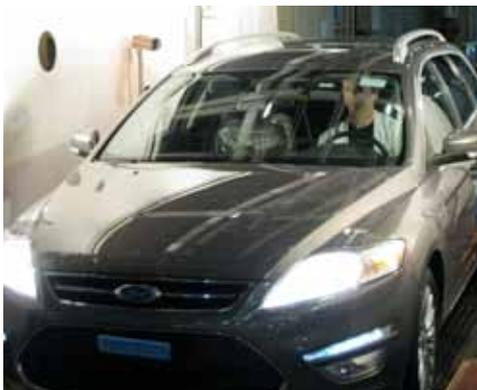
For each car model that has front window heating, the heating system is a bit different, that makes it difficult to test.

Ford is one of the few car manufacturers that produce cars with heated front windows. To make sure the driver’s vision isn’t obstructed by the heating elements the front window contains hundreds of little vertical heating elements instead of a few big horizontal ones. But according to Knuysen that made it difficult to set up a testing method. “For every type of car we produce here at Ford Genk the front window heating elements are a little bit different. Combined with the fact that the front window heating consists of many small heating elements this means that we cannot test the front window in the same method as we use for the rear window. That’s why we work with several square measurement areas. If any of those areas doesn’t heat up quickly enough the front window heating system is recorded as defective.”

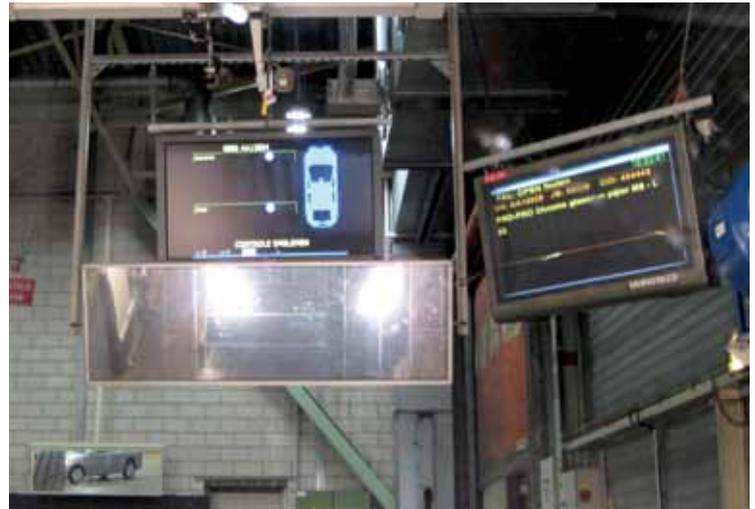
The screen next to the FLIR A320 thermal imaging camera that's pointed at the front shows the progress of the test.

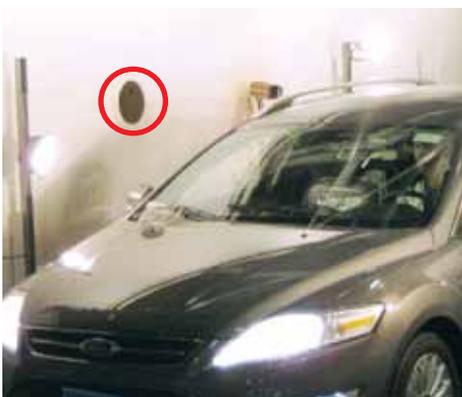
The thermal imaging camera behind the hole records the temperature of the air coming out of the air conditioning vent.

It started with the air conditioning test. "We were looking for a way to objectively test whether the air conditioning system was functioning properly, when we found that our colleagues at a Ford factory in Spain were using FLIR A-Series thermal imaging cameras for that purpose." To check the air conditioning system the test-driver opens the front right window and turns on the air conditioning at full power. The thermal imaging camera accurately records the temperature of the air emitted from the air conditioning vent and if the recorded temperatures deviate from the previously determined parameters it is sent for repair.

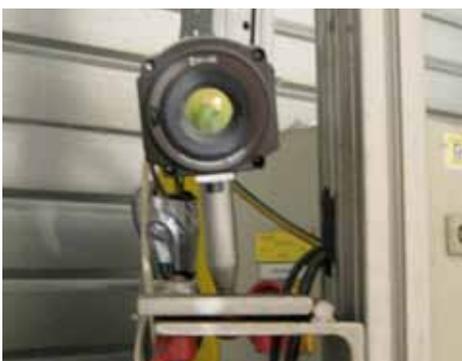
This FLIR A320 thermal imaging camera is used to check the air conditioning system.

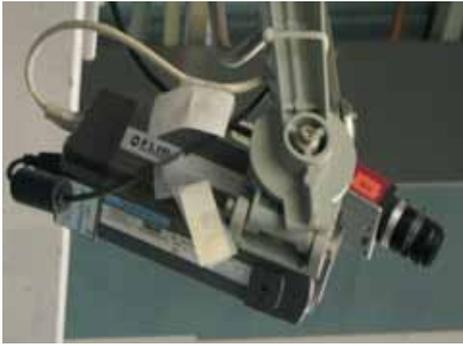
This FLIR A320 thermal imaging camera is used to check the rear window heating system for defective heating elements.

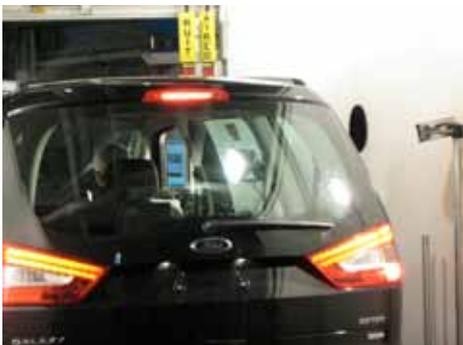
The test driver switches the rear heating elements on at full power.
