APPLICATION STORY

THERMAL IMAGING CAMERA, A TIME MACHINE FOR DAMP DIAGNOSIS

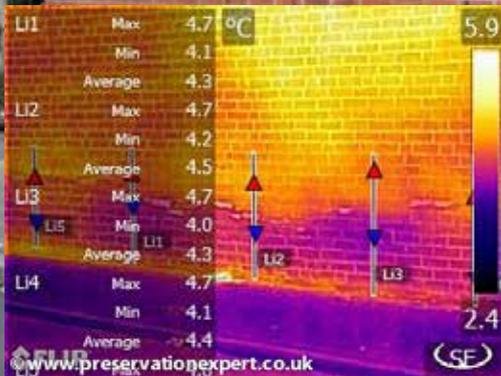
The FLIR T420bx offers sharp thermal resolution at 76,800 pixels for solid accuracy from farther away.

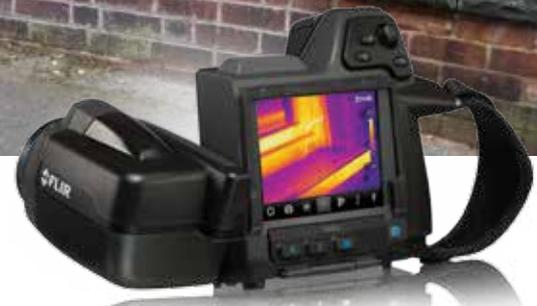
A tool for all seasons.... Bryan's FLIR T420bx is sensitive enough to 'see' warm areas in summer, where missing insulation is allowing heat in the roof void to radiate from the bedroom ceilings.

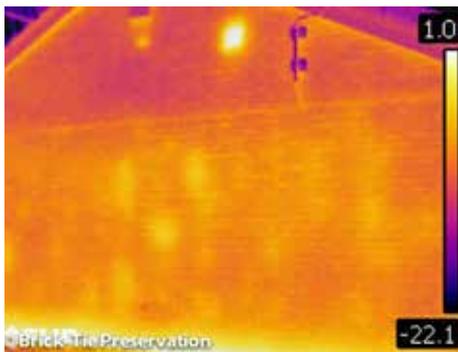
Gaps in cavity wall insulation identified using the FLIR T420bx for further investigation via boroscope, without the need to drill many holes.

The stand-out benefits of thermal imaging for Brick Tie Preservation is its ability to reveal missing or wet insulation and areas at risk of condensation; also for locating cold bridges such as blocked cavities. In traditional buildings it also helps the company find hidden timber frames and members, bricked-up openings and leaks.

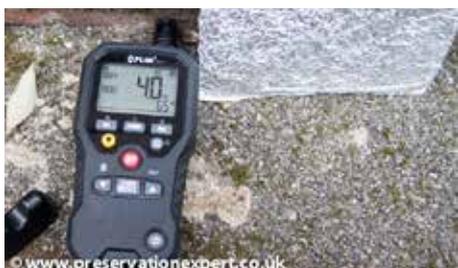
Bryan Hindle's FLIR MR77, used to transfer the psychrometric data to the FLIR T420bx via meterLink.

In this particular instance, Bryan Hindle used his FLIR T420bx in combination with his FLIR MR77 moisture meter. Both are equipped with Meterlink, a function that allows measurements from the moisture meter to be embedded in the associated thermal image.

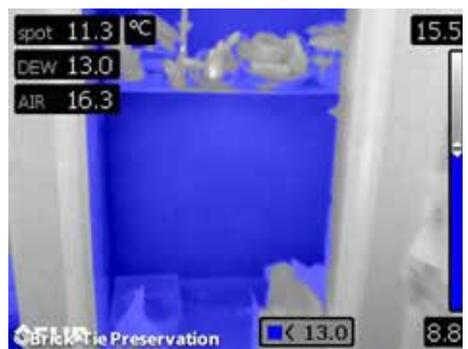
The use of a FLIR T420bx. Combined with MeterLink via a FLIR MR77 moisture meter in a damp investigation. Areas at and below the dew point (13.0°C) are highlighted in blue automatically, clearly identifying the areas where condensation is happening in real time. FLIR Tools software can be used to model changes based on expected changes following heating, insulation and ventilation interventions.

"Thanks to the technology I was recently able to show a surveyor that a house didn't require a full damp proof course, and lots of work, as the problem was simply one of condensation."

Bryan Hindle continued: "I'm able to give my clients an image with dew points and relative humidity overlaid on a colour isotherm taken of the property so they can see the result of the live readings from the moisture meter. It's a priceless communication tool and, in truth, I wouldn't consider buying a camera without this function now. I hate reports that bamboozle clients, so being able to supply the IR image with a clear explanation of what is going on works extremely well."
