FOUNDRY SPECIALIST SLR IMPLEMENTS THERMOGRAPHY: MAINTENANCE FROM A SINGLE MOLD

A FLIR T440 thermal imaging camera assures uninterrupted production at the SLR Group.

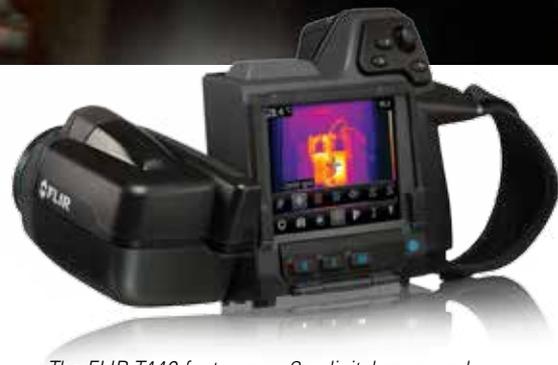
The FLIR T440 features an 8 x digital zoom and is equipped with the innovative Multi Spectral Dynamic Imaging (MSX) function.

inspecting the electrical installations. Based on Blug's advice, the SLR Group chose a FLIR T440 with a thermal resolution of 320 x 240 pixels and for an additional 45° interchangeable lens. The FLIR T440 has MSX technology, a patented FLIR technology which provides clear pictures and unmatched detail. MSX combines the thermal image with visible spectrum detail from the built-in 3.1 megapixel digital camera to provide a razor-sharp picture in which even individual labels on components can be read. The results can then be processed using the current version of FLIR Tools software. Alexander Czuberny was also impressed by the ergonomic and easy operation of the FLIR T440.

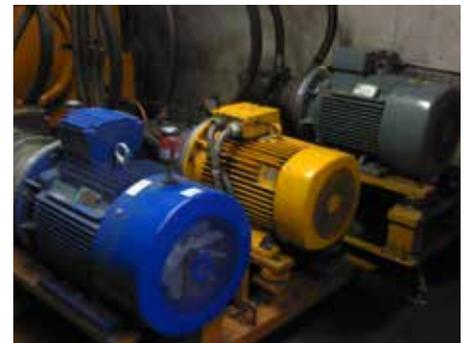
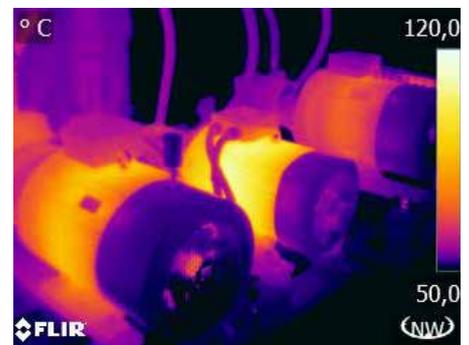
An overheated drive motor

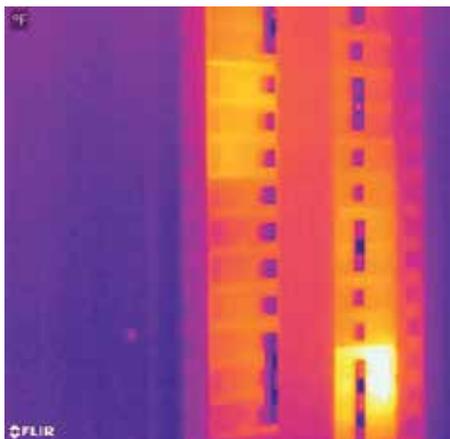
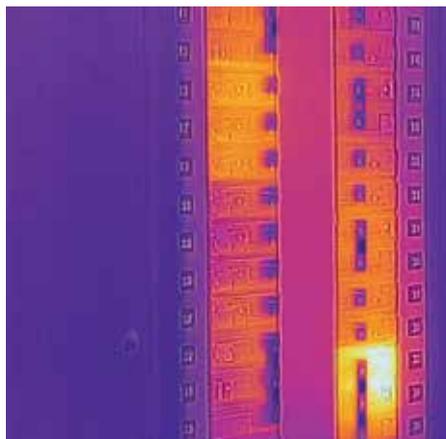
Compared to the standard thermal image, MSX technology (right) also shows essential details such as labels.

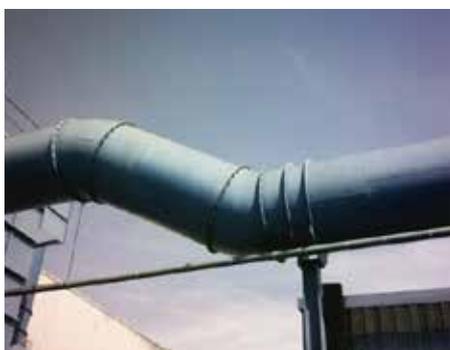
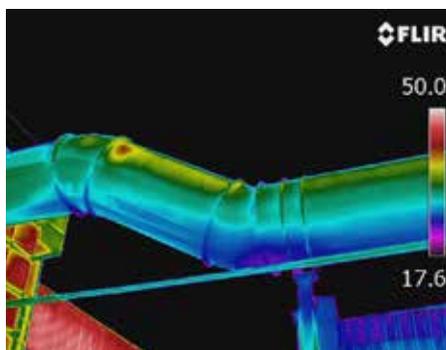
Even deposits in a pipe system can be seen in a thermal image.

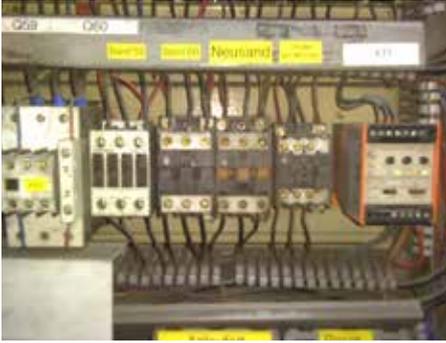
The temperature deltas of the components conducting electrical current are clearly visible in the infrared image. The thermographer's training and experience truly pay off when it comes assessing this thermal abnormality and recommending a course of action for the electrician.

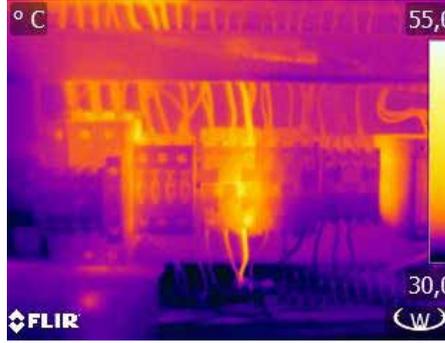
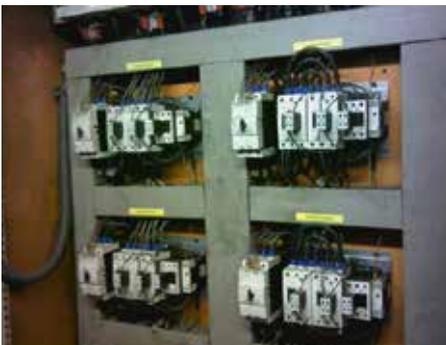
It is clear that the unit on the lower left needs to be checked by the electrician.

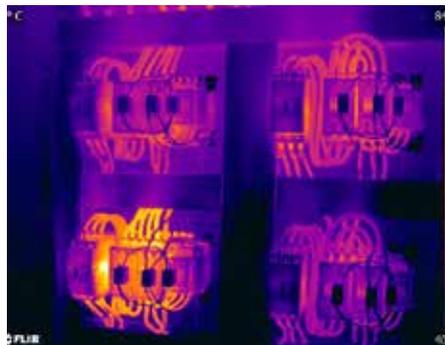
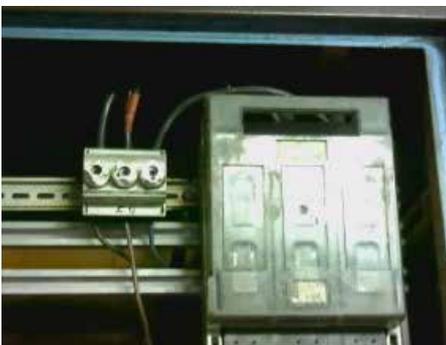
Of the 6 measuring points on this image, spot L2 is noticeably hotter than L1 and L3.

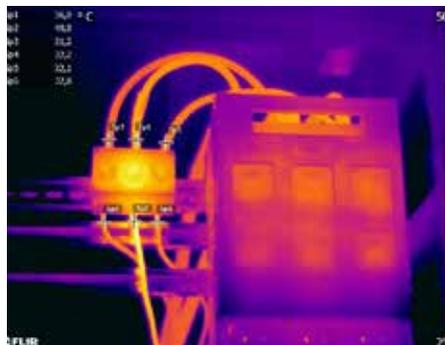
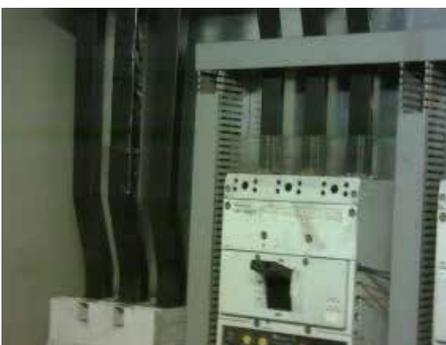
The middle rail requires inspection, because it is heating up to almost 80 degrees at some points.

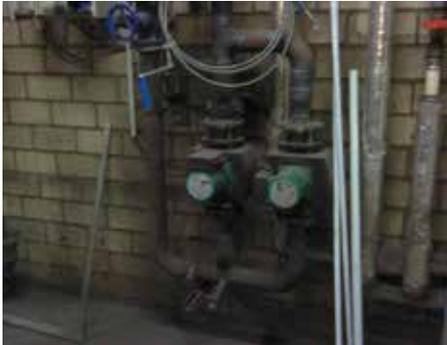
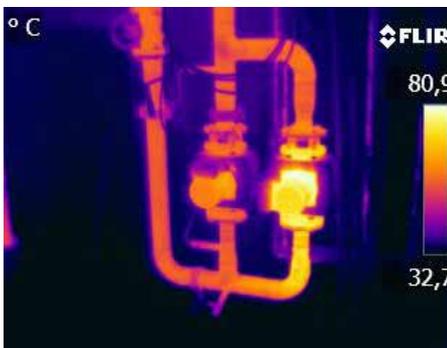
The image of the pump on the right was abnormal. Diagnosis revealed that it had been installed incorrectly.

Sometimes unusual problems also occur. For example, Czuberny had wondered why the temperature on the machine side of a pump, which is

used next to another one to pump hot material into a tank, was much too high on the intake side. The puzzle was solved: one pump had been connected backwards.

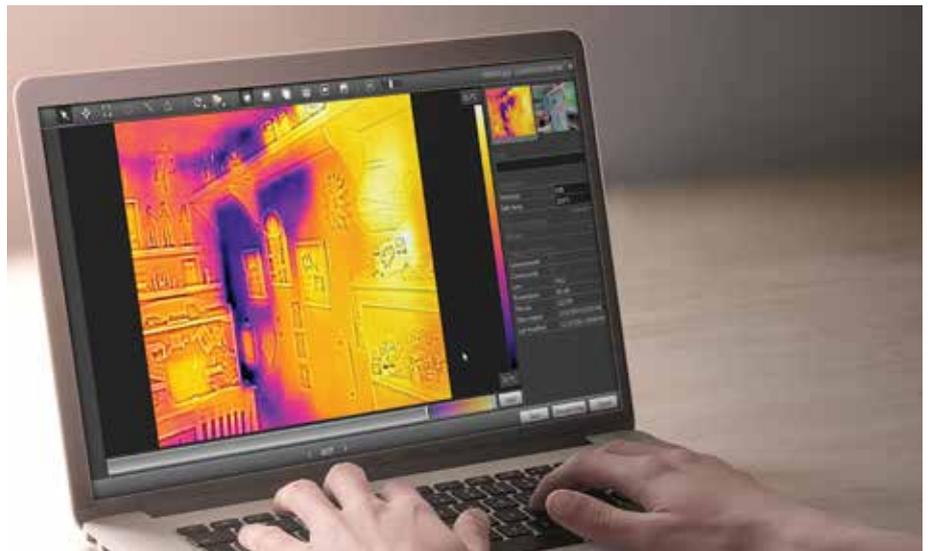
FLIR Tools (for PC and Mac) can be used to manipulate radiometric images to thermally adjust the level and span, to switch the range, or to alter parameter settings such as emission level, reflected temperature, etc.

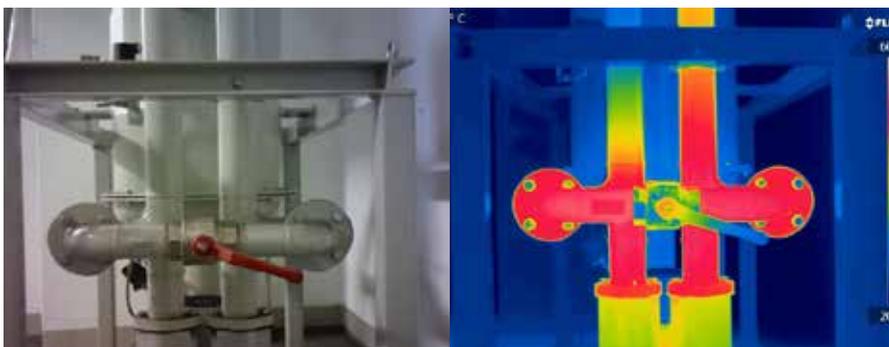
The thermal image clearly indicates which pipe has hot liquid passing through it.
