APPLICATION STORY

FLIR THERMAL IMAGING CAMERAS REVEAL HIDDEN DEFECTS IN FLOOR HEATING SYSTEMS

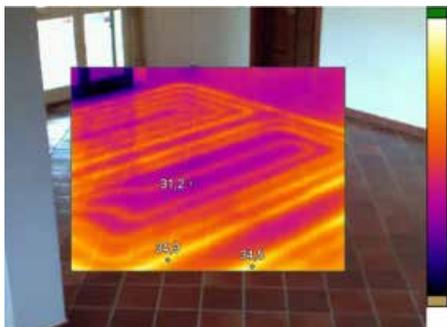
A thermal imaging camera clearly reveals the underground pipe network of a radiant heating system

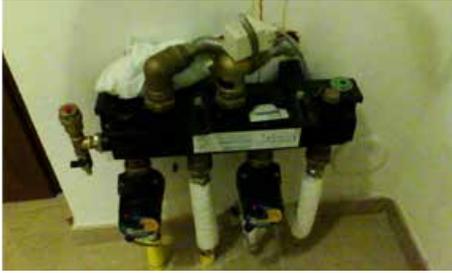
Figure 1a: Visual image of a manifold.

Figures 1a/1b/1c show a manifold that feeds a radiant heating system with circulator pumps, one for each manifold section. Points Sp1 and Sp2 actually are almost at the same temperature but having set the same emissivity value leads to misleading conclusions. In reality, electrical tape has been applied to Sp1, which has an emissivity that is very close to the value set in the instrument. Therefore, the fluid flow is actually at 44°C and not at 30.5 °C.

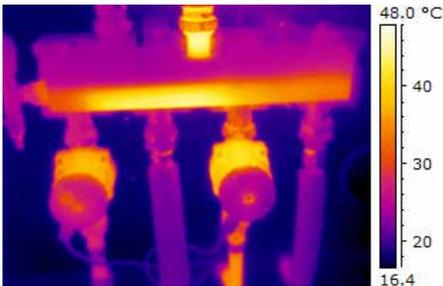
Figure 1b: Thermal image of a manifold with an inactive left pump.

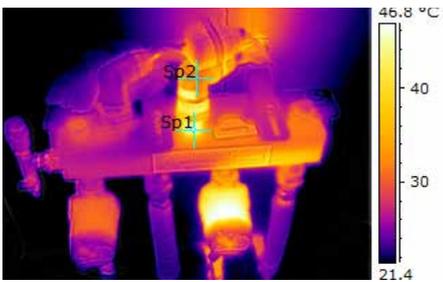
Figure 1c: Thermal image of a manifold with the left pump actively running.

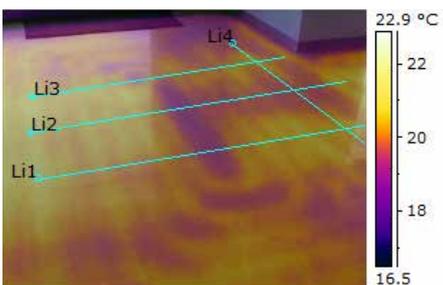
Figure 2: Radiant circuit during start-up

Figure 2 shows a radiant circuit during start-up, digitally fusing the thermal and the visual images. Profile analysis has been performed on the pseudo orthogonal lines Li1, Li2 and Li3, running over the pipes. On the right, line Li2 shows a colder, uneven area which should be investigated further, since it may mean that there are changes in the thickness of the screed or in the adhesive used for finishing. Line Li4, in green, highlights this thermal variation that should not occur along just a few decimeters of pipe.

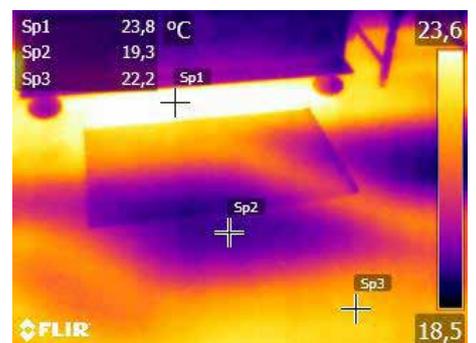
Figure 3: The presence of a radiant system behind furniture or other obstacles basically increases the inertia of the system both during startup and shutdown. Sp1 Temperature 23.8 °C, Sp2 Temperature 19.3 °C, Sp3 Temperature 22.2 °C

Be it as it may, the presence of a radiant system behind furniture or other obstacles basically increases the inertia of the system both during startup and shutdown and does not really help control the room's temperature. Actually, it creates a barrier to heat flow towards the areas occupied by the obstacles, a barrier which obviously has a cost in terms of energy. This is demonstrated in Figure 3.
